*Sheetlines*, 103 (August 2015), pp.54-55

## ***Internal divisions in buildings***

***Rob Wheeler***

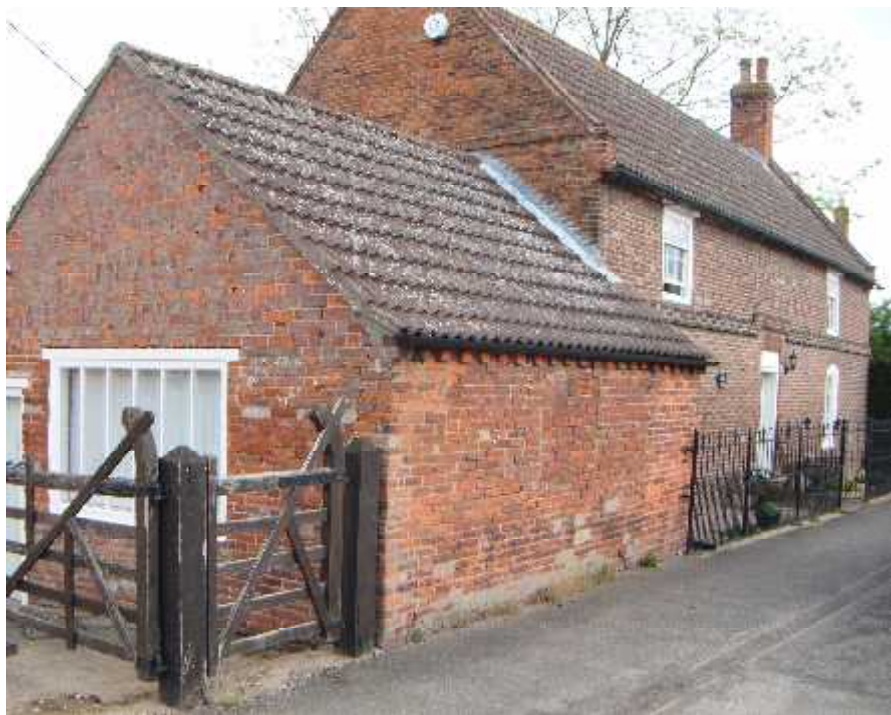
*Figure 1: Old Manor House, Bassingham*

The building at issue is shown in figure 1. It is an early-eighteenth century farmhouse on the site of the manor house belonging to one of the parts of the manor of Bassingham, Lincolnshire. It is built of brick, laid in Flemish bond. Nearest to the camera is a single-storey attachment with a complicated building history: the brickwork up to eaves level is of eighteenth century dimensions, laid in a form of garden-wall bond (the occasional courses of headers are at variable spacings) and with blocked openings. The gable is in larger, nineteenth century brickwork; faded paint declares it to be the premises of a painter and decorator. It is entered by a plank door and has a single window of a type often found in workshops of this date.
